Eliminating the Potential for Air and Moisture Infiltration at the Window-Wall Interface

Peter Poirier¹ and Brian Stroik²

ABSTRACT

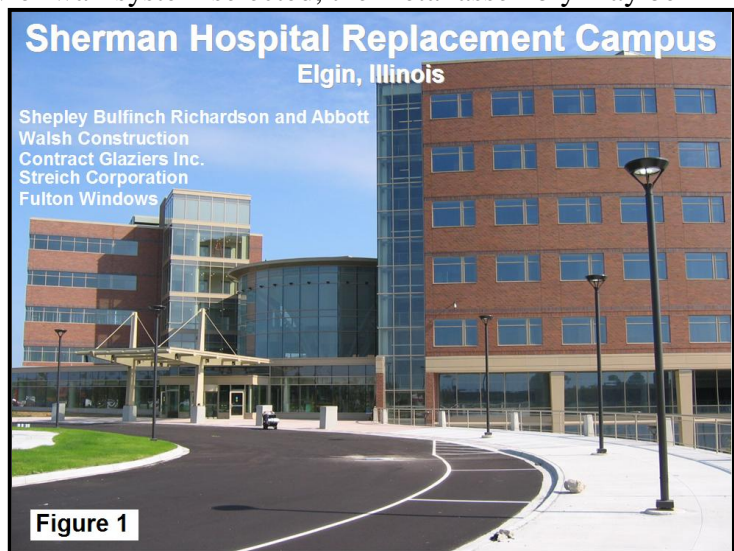
In order to maintain an effective air & vapor barrier (AVB), the barriers must be located within the wall assembly and be continuous from the roof-to-wall-to-foundation. To illustrate this principle, the case of the Sherman Hospital project in Elgin, Illinois, completed in 2007, will be discussed, where the rough opening for the wall terminations and their connections varied in size as a result of component and construction tolerances.

The original design called for the AVB membrane to wrap into the glazing pocket as shown in detail 01/D83. The construction sequence called for the curtain wall system to be installed after the brick veneer. This would leave a portion of the AVB membrane remaining unsupported in the rough opening, which could lead to potential damage. To install the curtain wall, the membrane would have to be cut in each corner to allow it to be folded out of the way. Sealing the cut membrane is difficult to achieve to provide an effective air and moisture barrier. AVB membranes are also not designed to span gaps unsupported, so the detail was revised as shown in Revision 1-01/D83.

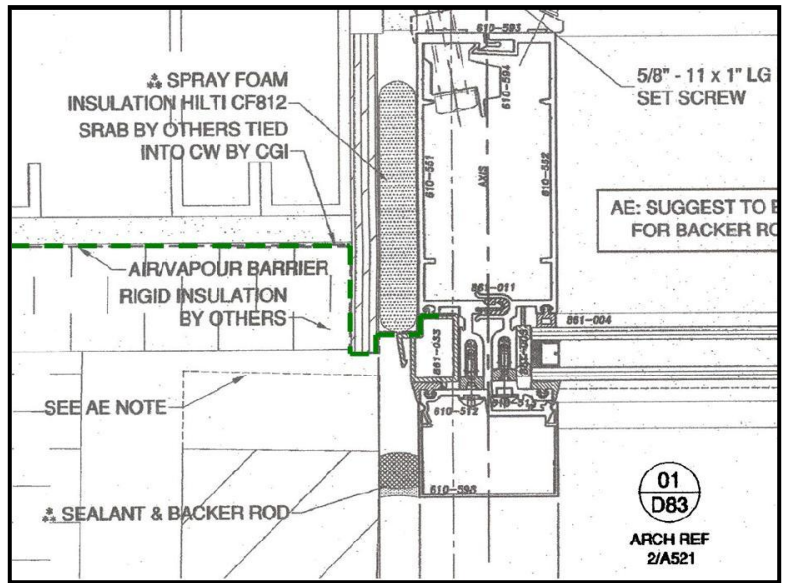
Some jamb conditions spanned over 100 ft. in height, which would have resulted in excessive weight from the silicone membrane and not allowing the sealant bead to properly hold the membrane in place while it was curing. To mitigate this, a metal adaptor was introduced to mechanically hold the silicone membrane in the metal adaptor with sealant while the sealant curing took place. This new detail is shown in Revision 2 – 01/D83.

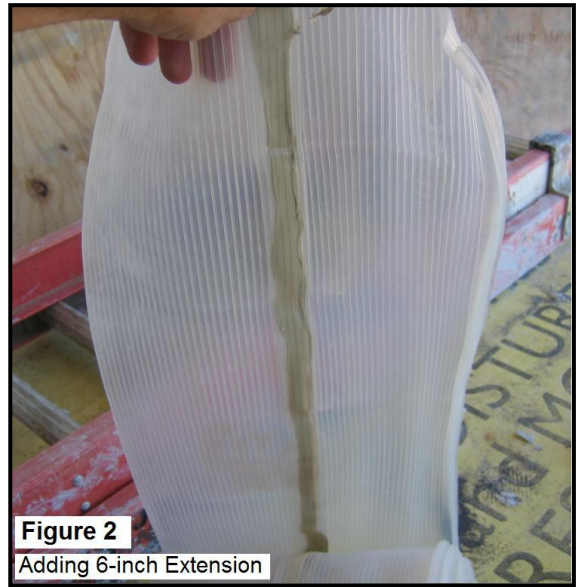
Because of construction issues and the need to compartmentalize the curtain wall from the cavity behind the brick veneer, it was necessary to bond an additional 6 in. wide silicone membrane (as shown in Figure 2) to the existing silicone membrane. This allowed the material to span from the self-adhered AVB membrane and onto the leading brick edge (as shown in Figure 3) and then into the curtain wall's glazing pocket (as shown in Figure 4).

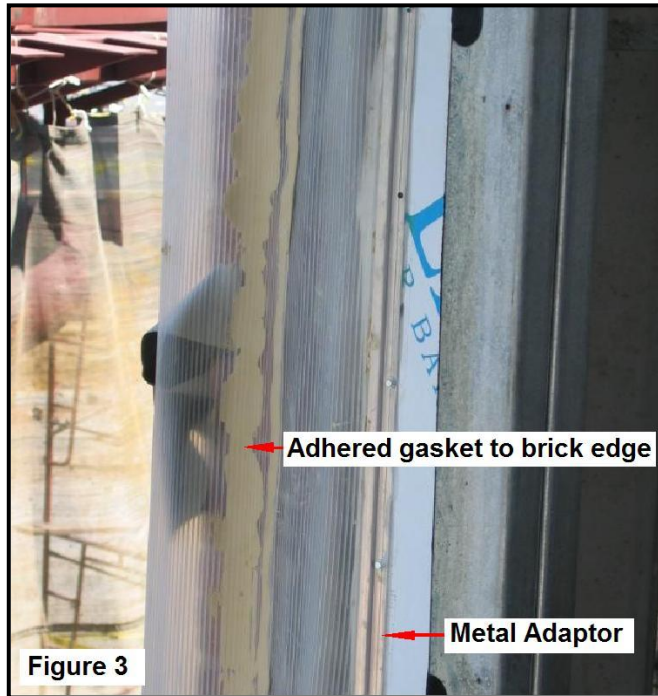
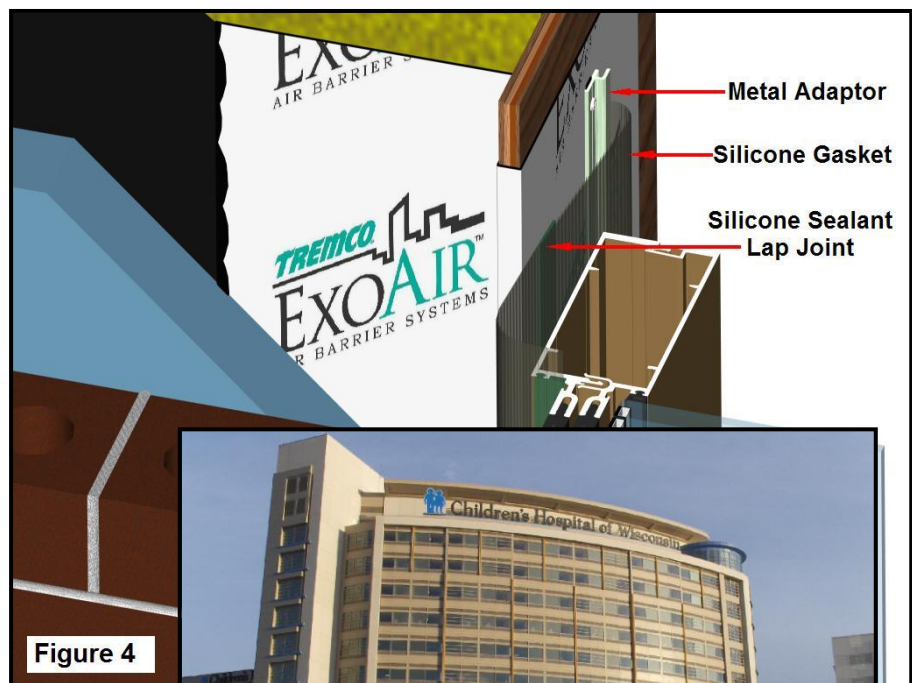
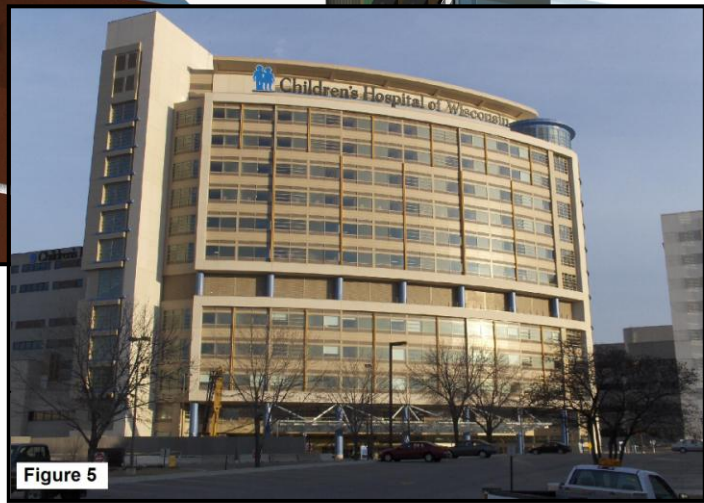
In another case, the general contractor for the Children's Hospital Bed Tower in Wauwatosa, Wisconsin (as shown in Figure 5) knew from previous projects that the connections and transitions for the AVBs were critical. The glazing contractor erecting the unitized curtain wall system had used an engineered transition assembly to connect windows to the AVB membrane on previous projects. They requested that the curtain wall manufacturer pre-apply the metal adaptor in its shop to save field labor and allow the connection to be completed once the unitized curtain wall was erected on-site.

The engineered transition assembly system allowed the glazier to make the field connection to the self-adhered AVB membrane (as shown in Figure 6) before installation of the composite metal panels and to connect onto the surrounding pre-cast conditions while also allowing it to accommodate the wall movement in the expansion joint under the hanging curtain wall (as shown in Figure 7). The silicone membrane easily accommodated construction tolerances and changes in plane with the wall and pre-cast panels to maintain a continuous seal with the AVB within the wall assembly.

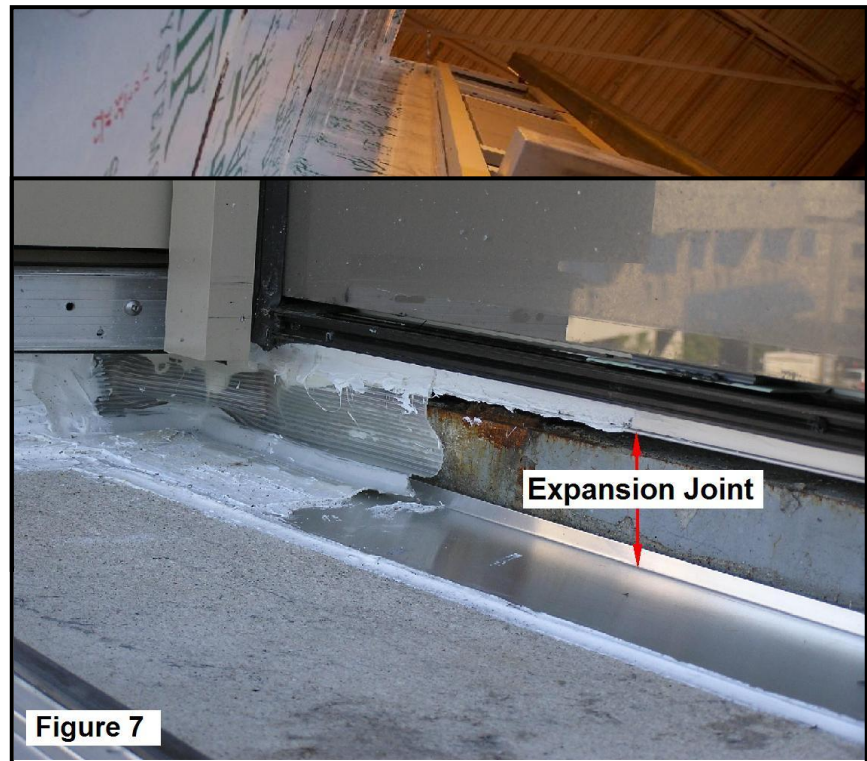
Figure 7

The head and jamb shop details show how the metal adaptor was installed and sealed into the glazing pocket in the curtain wall manufacturer's factory. This allowed the installer to apply a small amount of silicone sealant into the metal adaptor race and insert the silicone dart. The dart's engagement in the metal race supported the gasket's weight and allowed the gasket to span onto the AVB membrane where it was adhered with additional silicone sealant to finish the connection. Pre-molded silicone corners allowed a continuous connection from the head, down the jambs, and along the sill by allowing simple 1 in. wide lap joints.

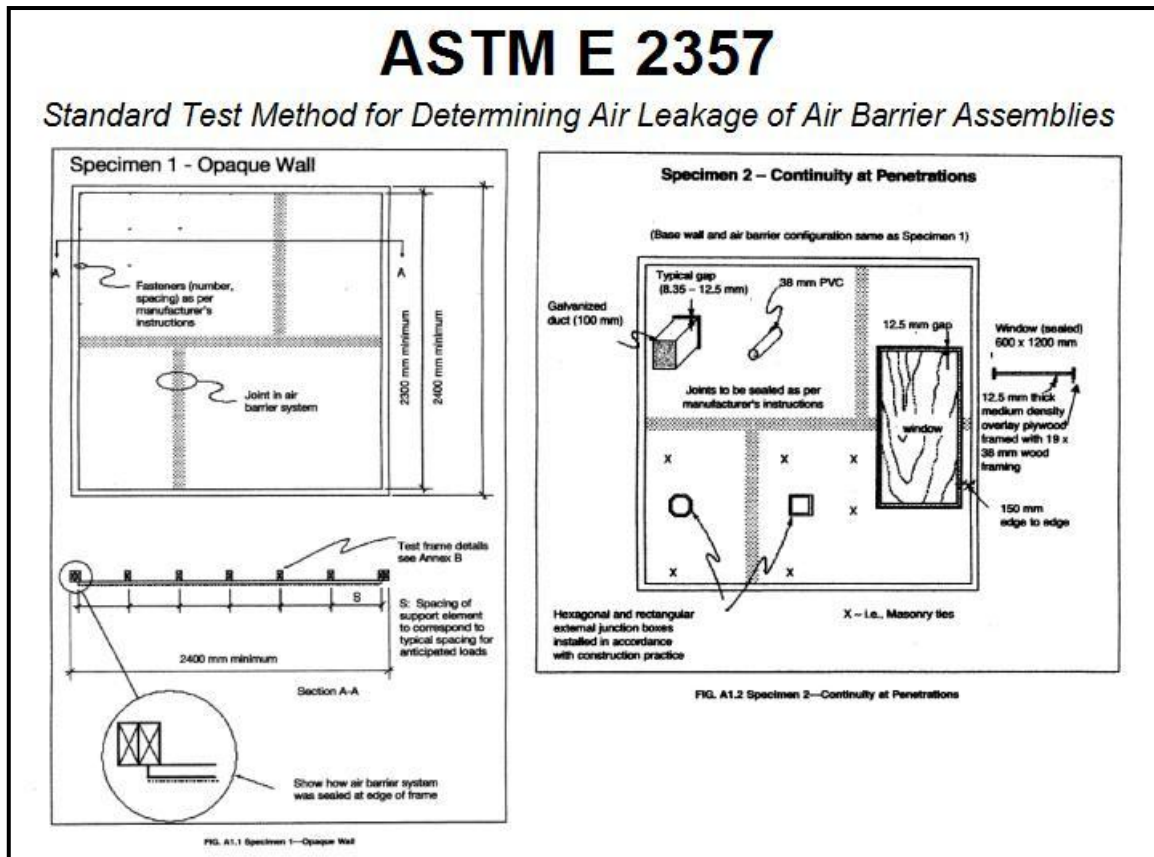
ASTM E2357– *Standard Test Method for Determining Air Leakage of Air Barrier Assemblies* is the first of several test methods to help ensure the air barrier components will work and perform as a system. This test method is accomplished by testing a minimum of two 8 ft x 8 ft wall specimens. The first unit is constructed to form a solid opaque wall with an applied air and vapor barrier with no penetrations. The second wall has a pre-defined window opening, irregular shaped electrical junction boxes, duct work and pipe penetrations, which all must be sealed to the AVB membrane. After cyclic testing these assemblies for both positive and negative air pressure, each wall assembly must not exceed 10% of specimen 1.

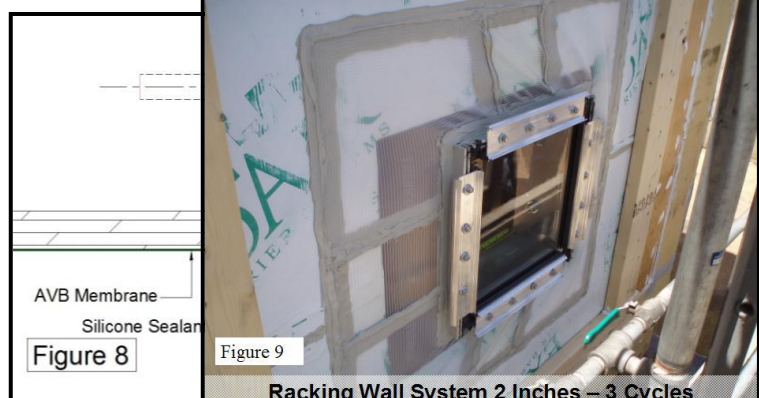
Recommended Static Test Method for Evaluating Curtain Wall and Storefront Systems Subjected to Seismic and Wind Induced Interstory Drift should be considered. Modified versions of this test method can help in evaluating the movement capabilities of the connections both thermally and seismically. As shown in Figure 8, a 40 durometer Shore A silicone extrusion with a dart was inserted into a mullion race filled with silicone sealant. This silicone gasket will span the 3 in. gap between the window frame and the rough opening. The end of the gasket is adhered with silicone sealant onto the AVB membrane. This silicone gasket was able to absorb lateral racking movement of 2 in. (as shown in Figures 9 and 10) and withstand structural wind loads of ± 150 psf, without any physical damage (as shown in Figure 11).

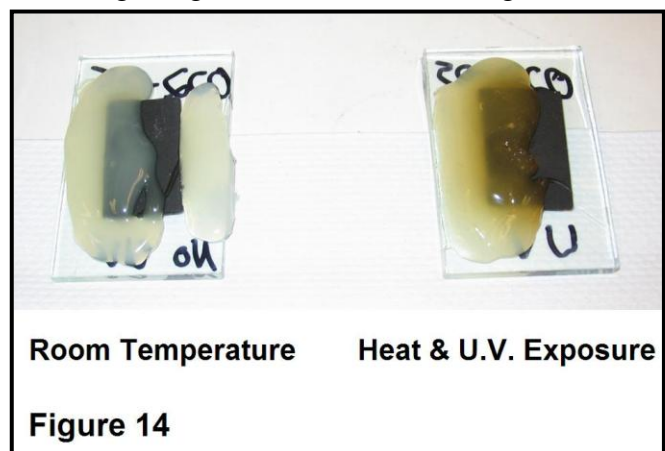
Figure 14 – Sealant in contact with rubber extrusions.

Compatibility must be confirmed with all the wall components in contact with the sealant. Sealant manufacturers may use **ASTM C1087 – Standard Test Method for Determining Compatibility of Liquid-Applied Sealants with Accessories Used in Structural Glazing Systems**. This laboratory screening process, which is often used for non-structural glazing applications, looks for any change in the sealant’s color, as well as change in adhesion of the sealant to the glass and/or accessory material. There are applications where the AVB membrane may extend into an exterior perimeter sealant thus causing an aesthetically unacceptable discoloration. Silicone sealants will discolor from the migration of asphaltic components from the self-adhered flashing into the sealant. Whether this migration will cause a loss of adhesion to the substrates will be evaluated by this testing. The photo shown is an example of a rubber gasket in contact with a silicone sealant and the rubber plasticizers/oils migrating into the sealant (see Figure 14).

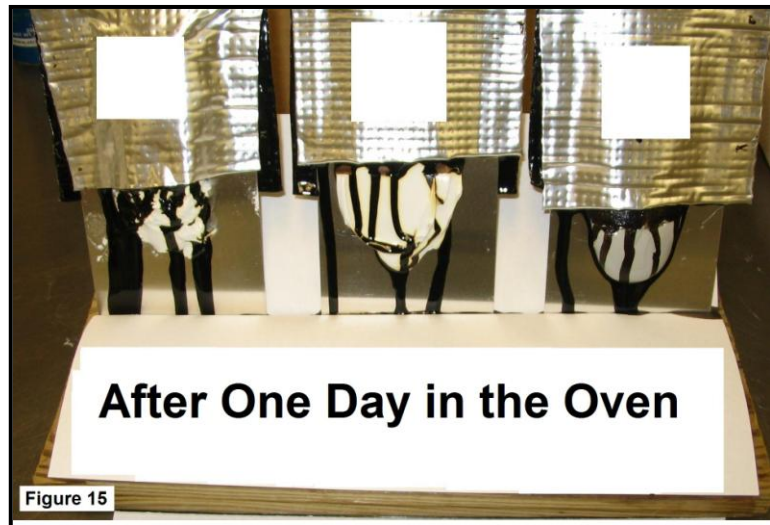
AAMA has recently published a new document titled: **713-08 – Voluntary Test Method to Determine Chemical Compatibility of Sealants and Self-Adhered Flexible Flashings**. This test method was developed to verify compatibility of self-adhered flashings with adjoining sealants. The AAMA task group documented that certain sealants have the potential to cause the self-adhered flashing’s adhesive or sealant to soften, slump and/or even liquefy, resulting in reduced effectiveness of the membrane (as shown in Figure 15). The task group reported cases of

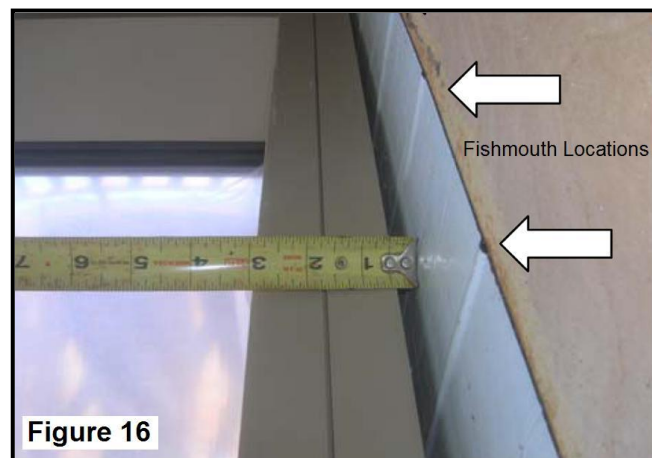
Self-adhered membranes generally have an aggressive bond once properly positioned. The process of cutting, notching and folding the flexible membrane around rough openings and penetrations can be difficult and often results in wrinkles and/or "fishmouth" gaps in the membrane, which are difficult to remove or seal (as shown in Figure 16). These conditions can result in air and water infiltration. This is why many manufacturers state in their literature that these conditions or defects must be repaired by replacement, which is often overlooked by the installer.

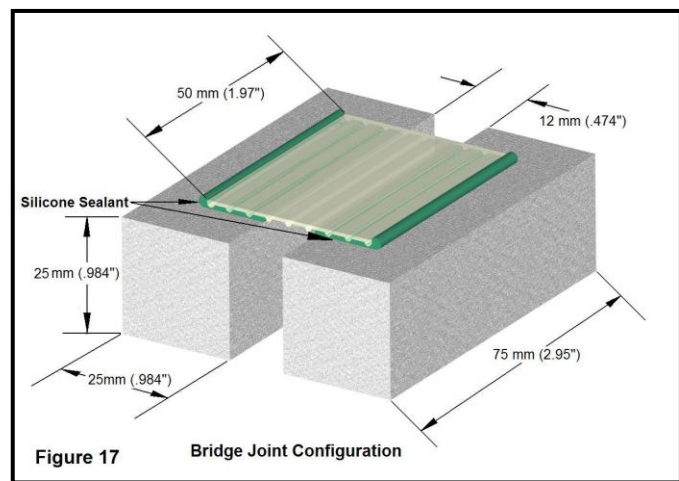
Our testing used a bridge joint configuration as shown in Figure 17 with the orientation of the extruded ribs running parallel with the joint. This will mimic how the product is used in the field. Once the specimens were constructed they were tested per a modified ASTM C1523 Standard Test Method for Determining Modulus, Tear and Adhesion Properties of Precured Elastomeric Joint Sealants.

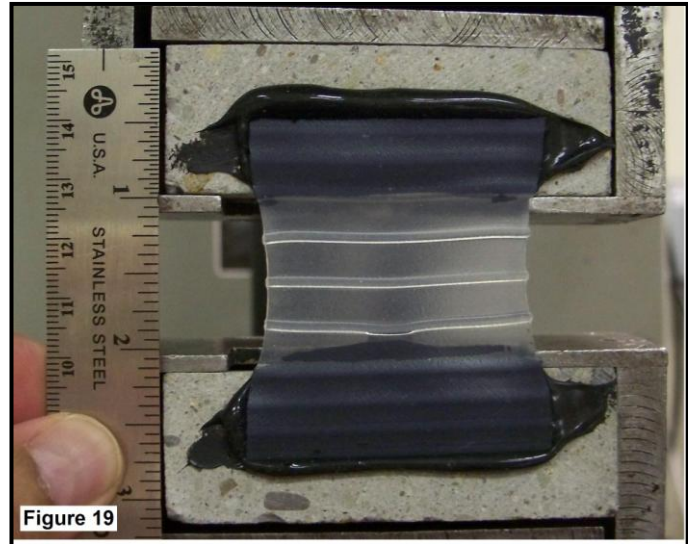
Figure 19 – Test specimen mounted in tensile tester.

- Loss of cohesion at 200% elongation
- Ultimate elongation at peak load
- Peak tensile load over length of joint
- Description of kind of tear if any after 1 hr hold at 200% elongation
(See Figure 19)

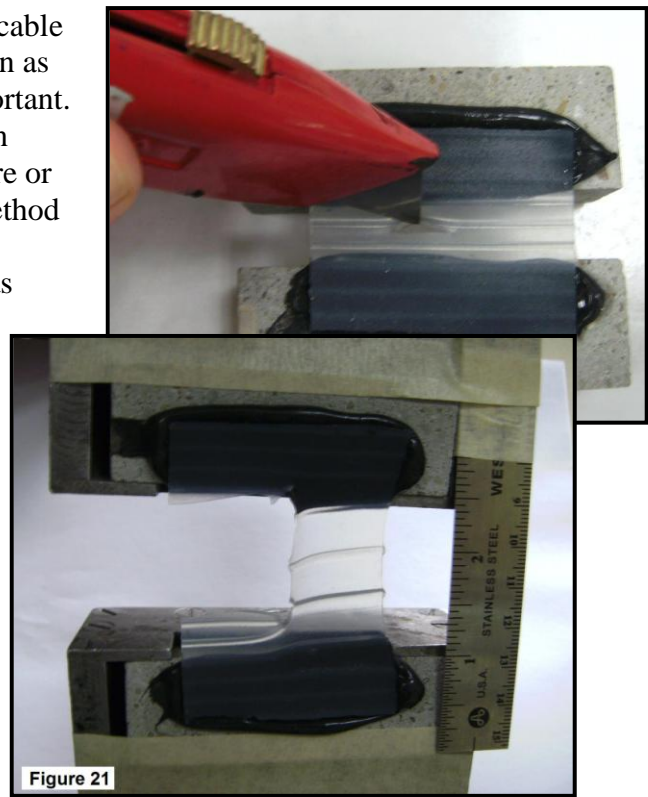
Figure 21

To determine the tear class, the specimens are cut mid-span after cycling (as shown in Figure 18). The type of tear propagation is recorded. As shown in Figure 21, the tear propagated perpendicular to the cut.

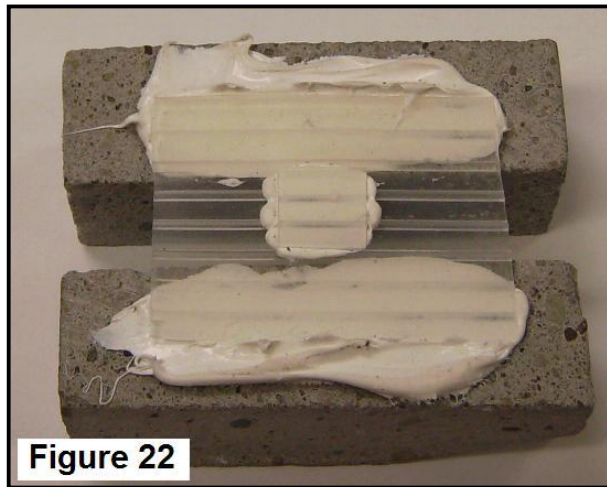
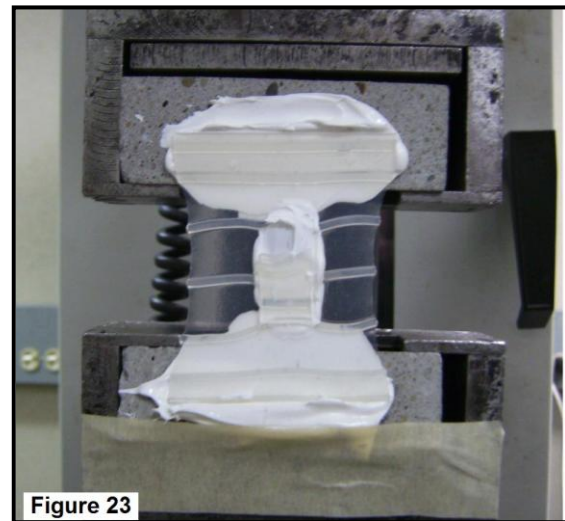
by applying a small bead of silicone sealant covered with a small 5 mm x 5 mm patch of the same membrane, much like a tire patch, the assembly passed the test (as shown in Figure 22). We allowed the assembly to cure for 7 days and

then extended the membrane 200% for one hour, cycled the assembly ten times at 200% and observed no adhesive or cohesive loss (as shown in Figure 23).
